The European Union's Project IPA 2009, Implementation of Energy Efficiency Measures in Schools and Hospitals in Kosovo

**SUPERVISION OF ENERGY EFFICIENCY MEASURES
IN SCHOOLS AND HOSPITALS IN KOSOVO
Contract No. 2012/302-059**

*Photo Report, on the applied energy
efficiency measures in 6 of 53 schools
(Located in 30 Kosovo municipalities)*

PHOTO REPORT ON A FEW TYPICAL SCHOOLS, BEFORE EEM AND AFTER EEM IMPLEMENTATION OF ENERGY EFFICIENCY MEASURES

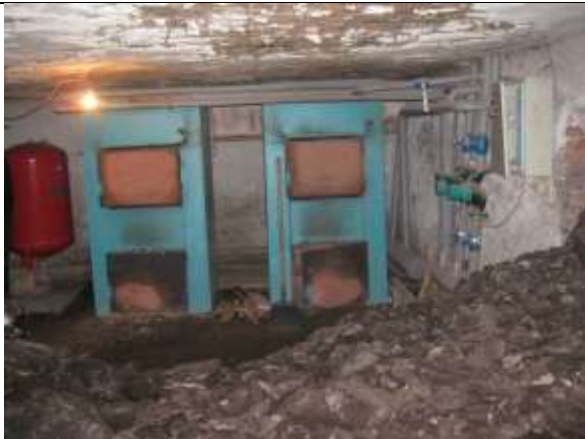
Figure 3: Wood and coal Boilers

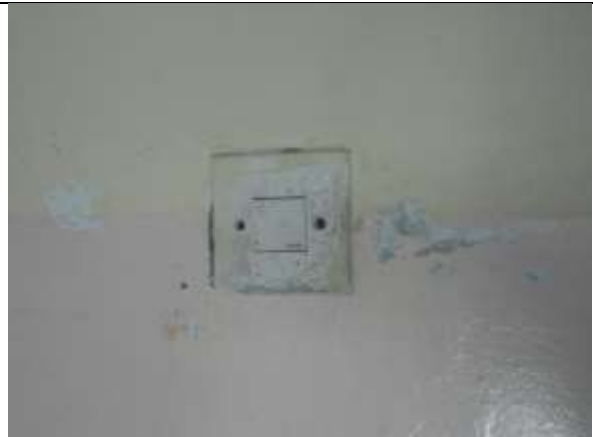
Figure 6: old electrical switch

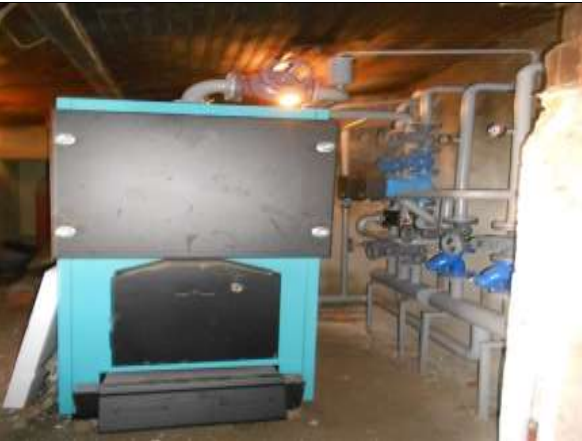
Figure 3: Energy efficient boiler

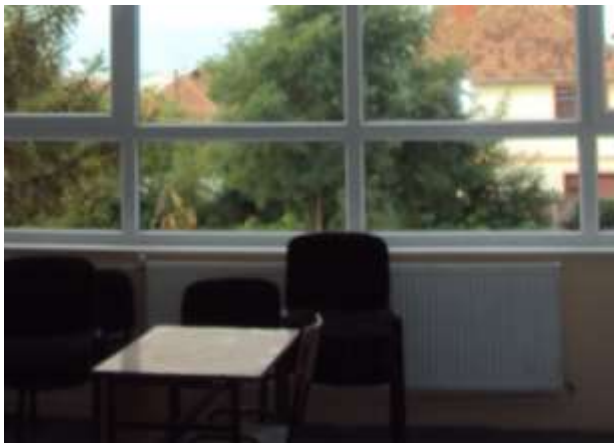
Figure 4: refurbished radiators

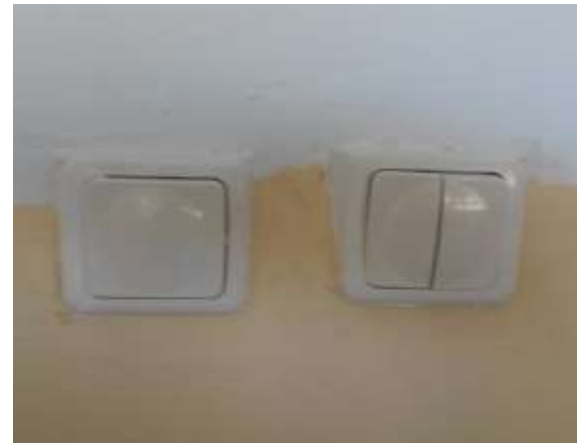
Figure 6: new electrical switches

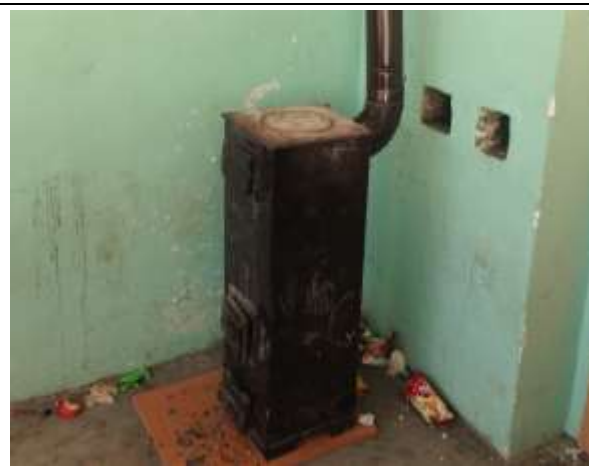
Figure 4: Existing stoves

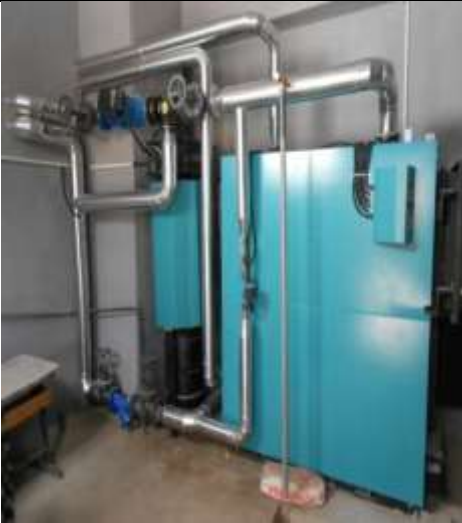
Figure 3: Energy efficient boilers

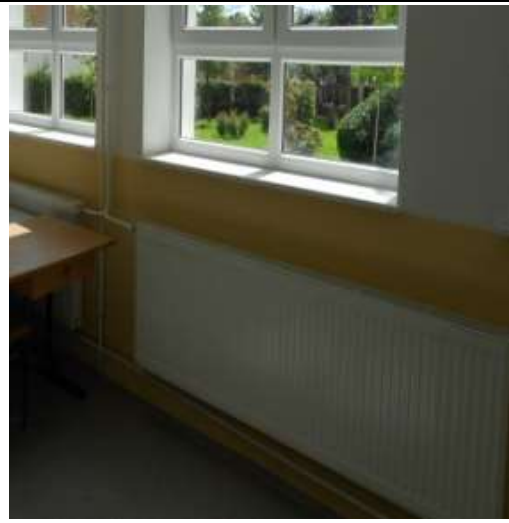
Figure 4: New radiator , refurbished installation

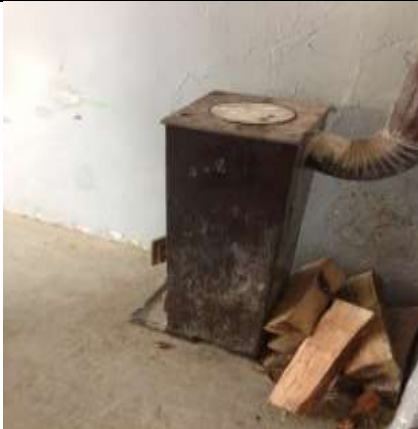
Figure 3: Existing wood stoves

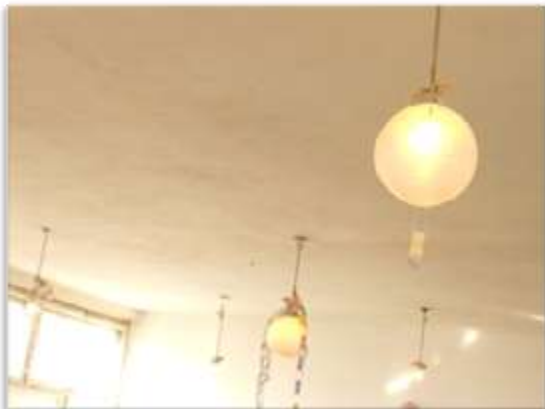
Figure 5: Suspended Incandescent luminaries

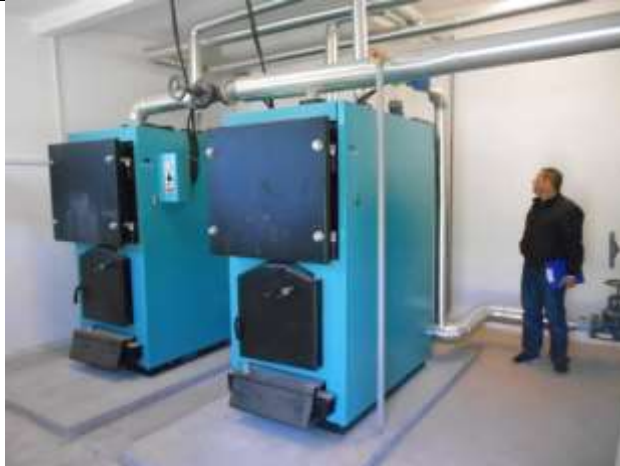
Figure 3: Energy efficient boilers

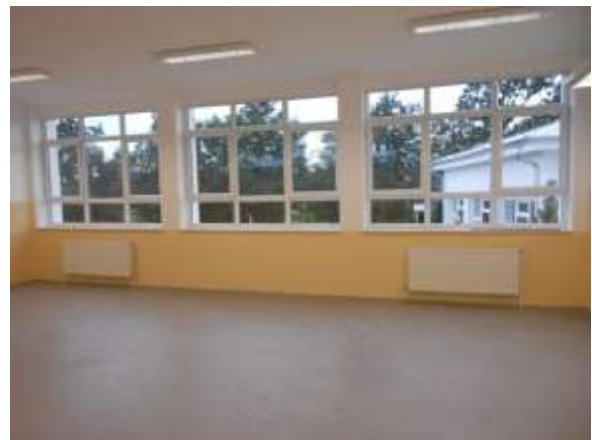
Figure 4: New radiator and refurbished installation

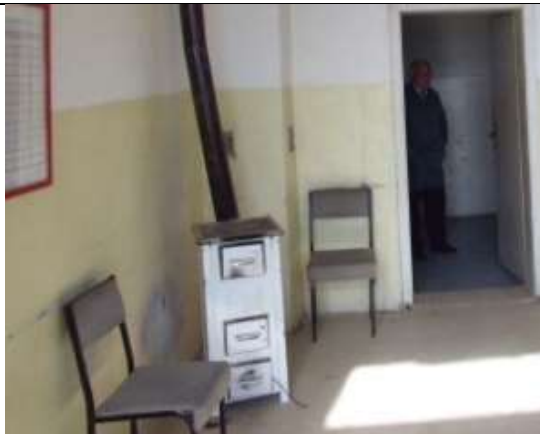
Figure 3: Existing stoves

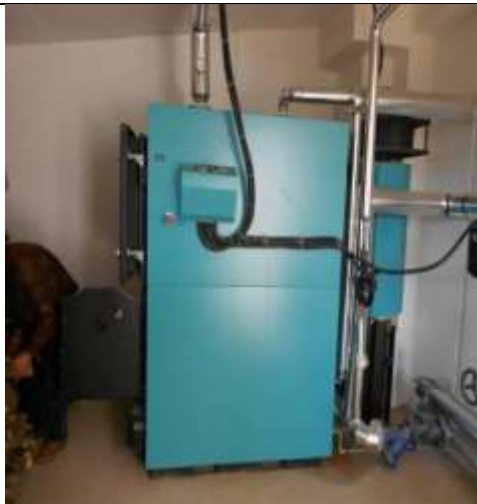
Figure 3: Energy efficient boilers

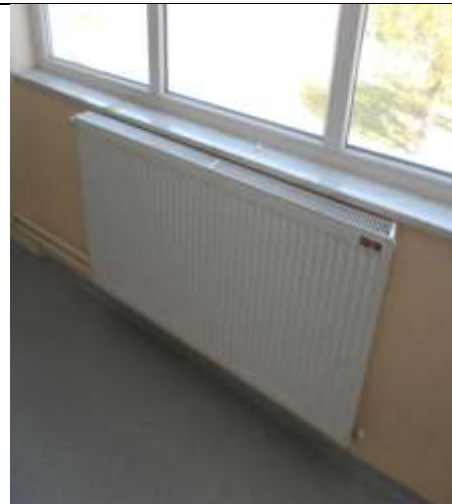
Figure 4: New radiator and refurbished installation

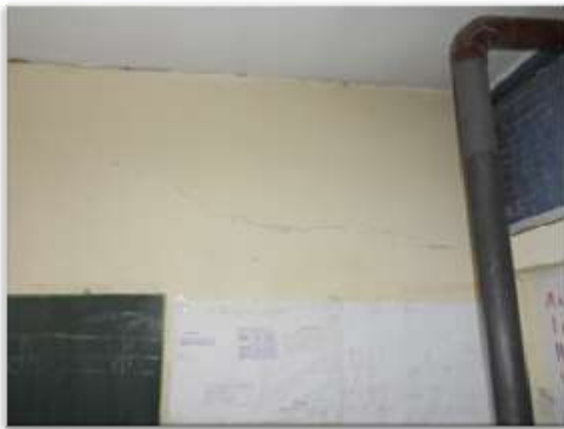
Figure 3: Existing Stoves

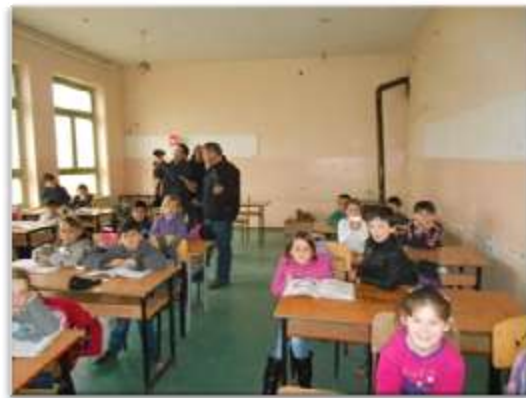
Figure 4: Existing radiators

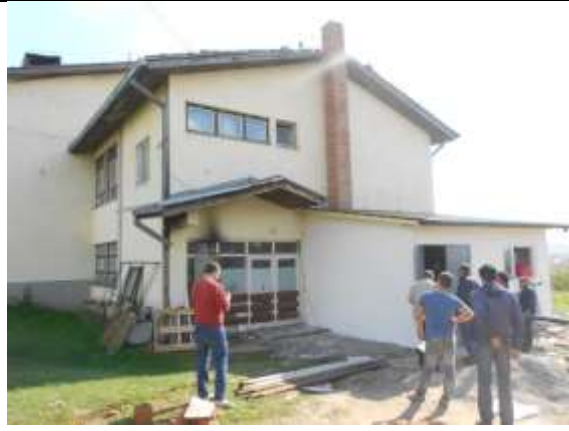
Figure 20: existing Annex and boiler room

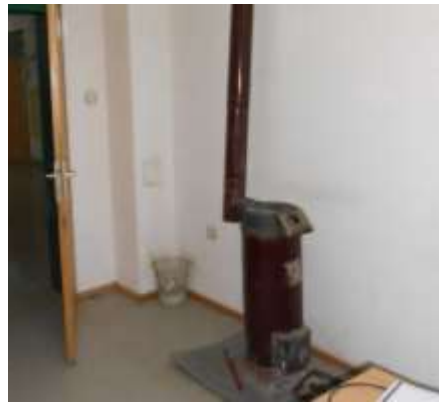
Figure 4: Existing stoves

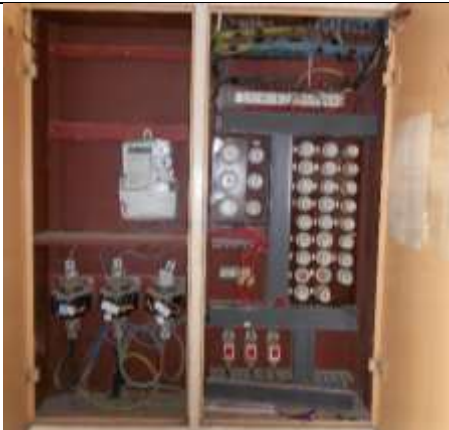
Figure 5: Existing Distribution Board

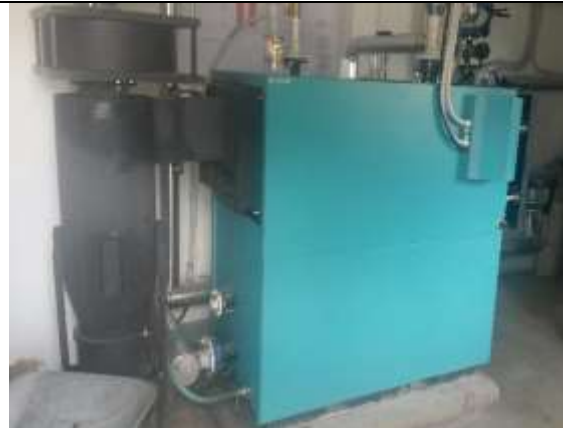
Figure 3: New boiler

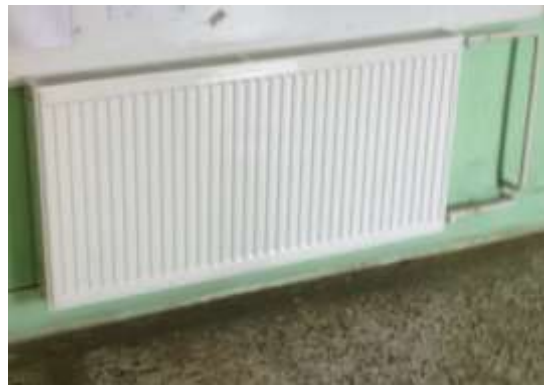
Figure 4: New radiator

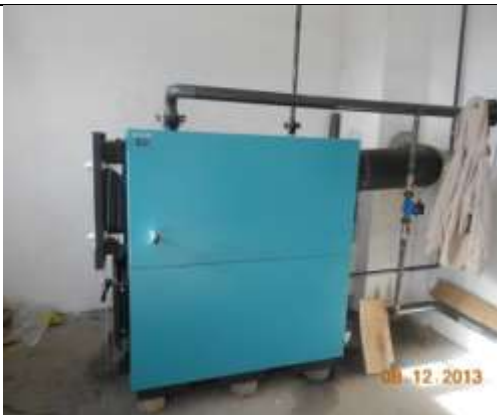
Figure 3: Energy efficient boilers

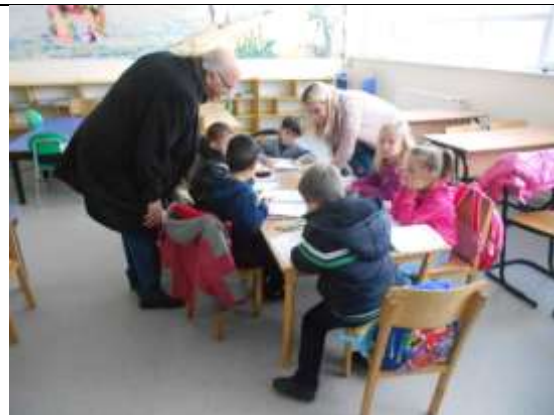
Figure 4: New radiator and refurbished installation
