The European Union's Project IPA 2009, Implementation of Energy Efficiency Measures in Schools and Hospitals in Kosovo

**SUPERVISION OF ENERGY EFFICIENCY MEASURES
IN SCHOOLS AND HOSPITALS IN KOSOVO
Contract No. 2012/302-059**

*Photo Report, on the applied energy
efficiency measures in 6 of 53 schools
(Located in 30 Kosovo municipalities)*

PHOTO REPORT ON A FEW TYPICAL SCHOOLS, BEFORE EEM AND AFTER EEM IMPLEMENTATION OF ENERGY EFFICIENCY MEASURES

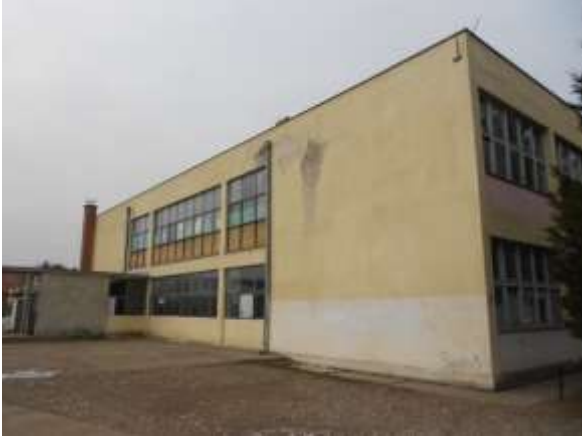
Figure 1: Side & Rear Facade

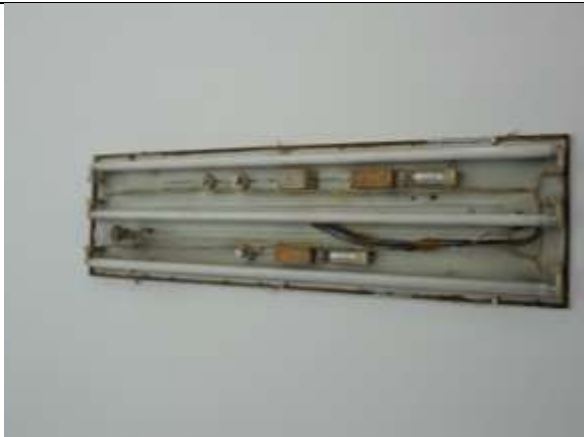
Figure 5. surface mounted luminaries

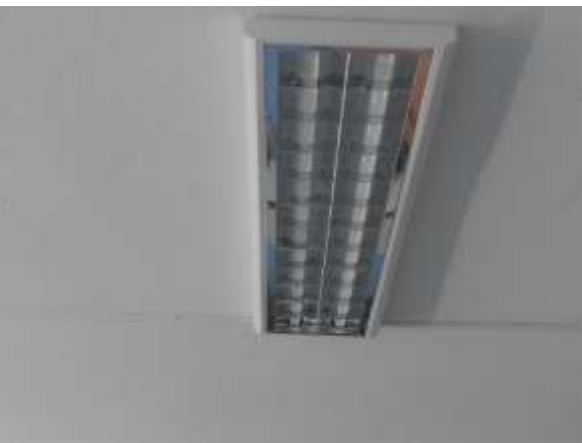
Figure 5: New surface mounted luminaries

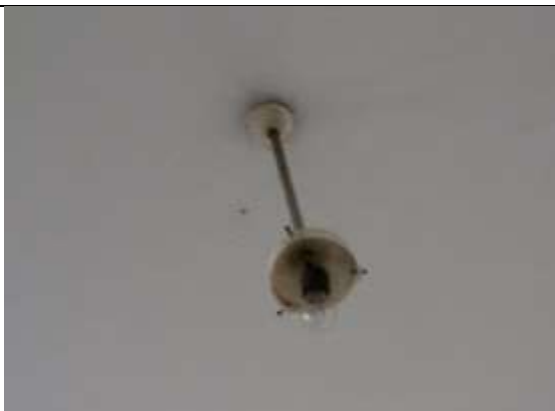
Figure 5: surface mounted luminaries

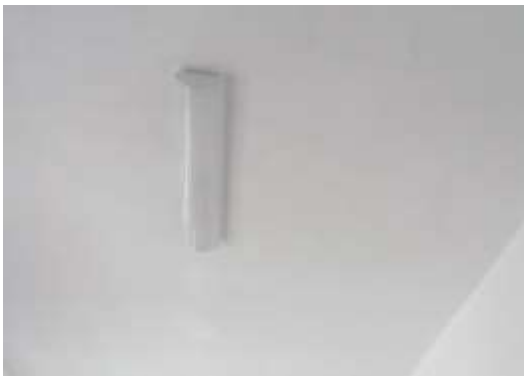
Figure 5: New surface mounted luminaries

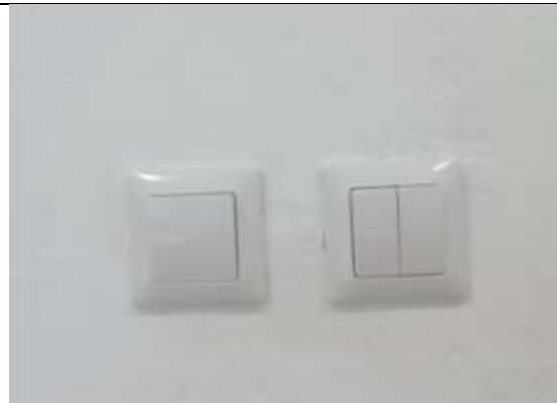
Figure 6: New manual switch

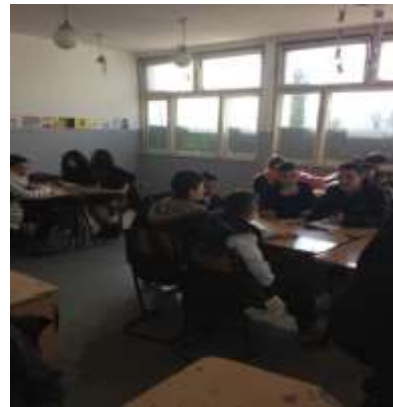
Figure 4: classrooms without radiator system

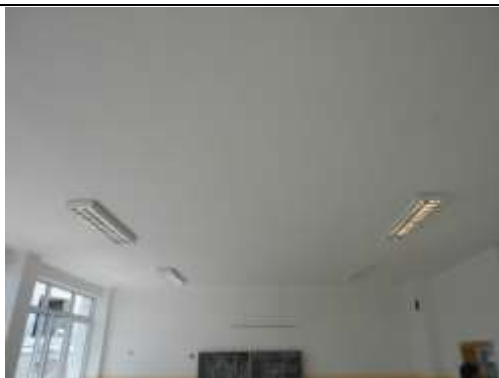
Figure 5: New surface mounted luminaries

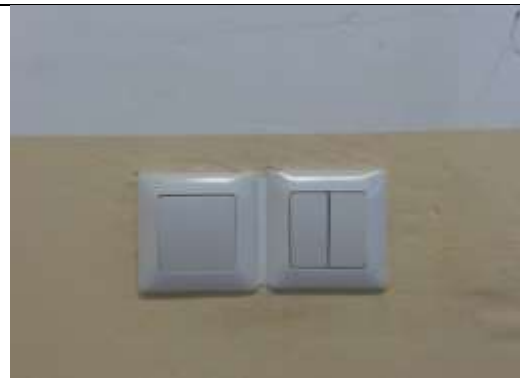
Figure 6: New manual switch

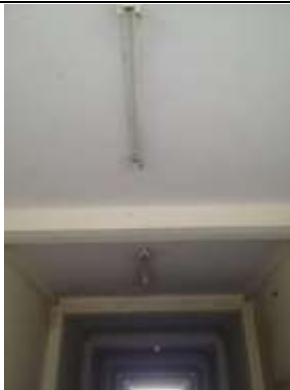
Figure 5: Surface mounted luminaries

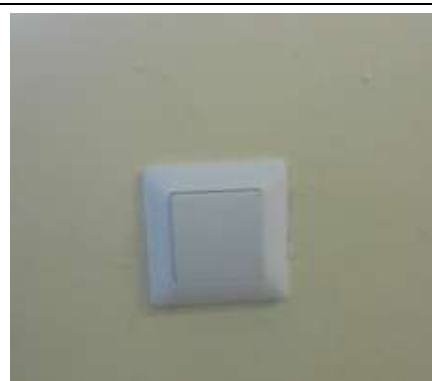
Figure 6: New manual switch

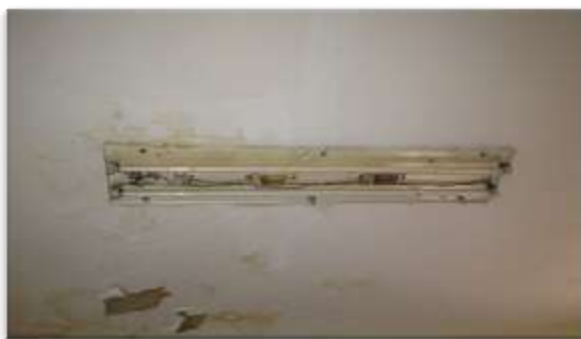
Figure 5: Surface mounted luminaries

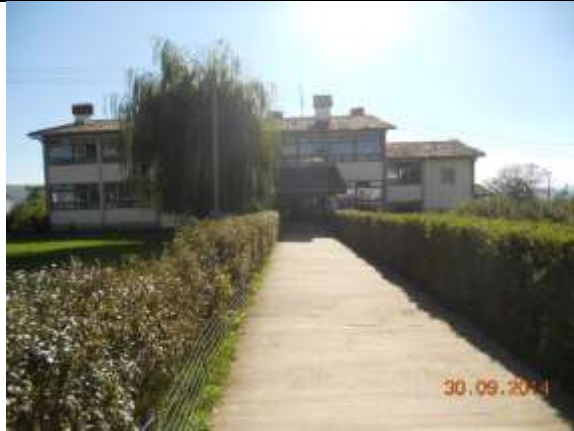
Figure 19: Front and Side Facade
Mechanical Installations

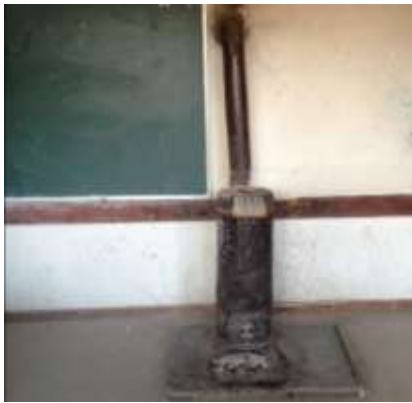
Figure 3: Existing stoves
Electrical installation

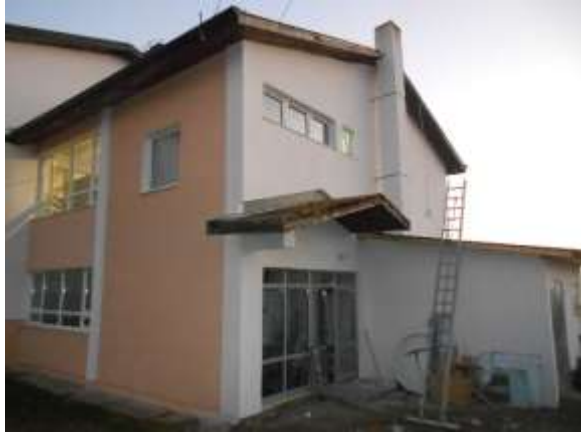
Figure 22: Rear Façade and Boiler room

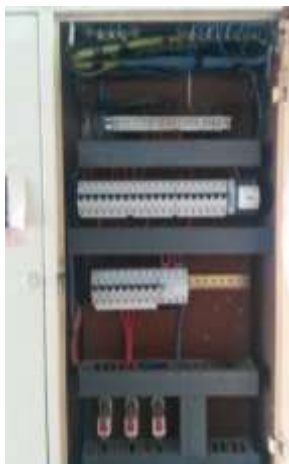
Figure 5: New manual switches

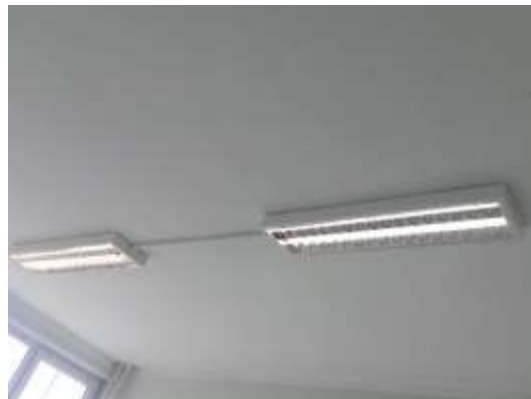
Figure 6: New surface mounted luminaries

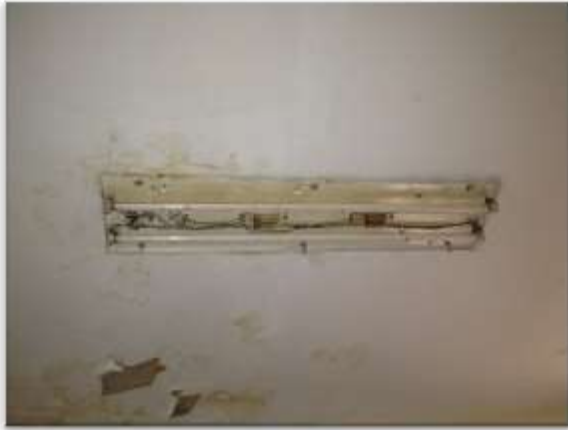
Figure 5: Surface mounted luminaries
AFTER EEM EE MEASURES

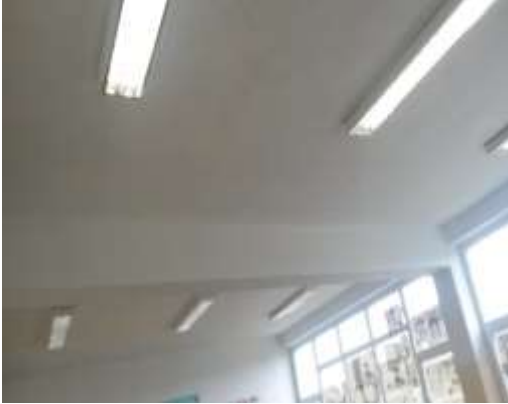
Figure 5: New surface mounted luminaries

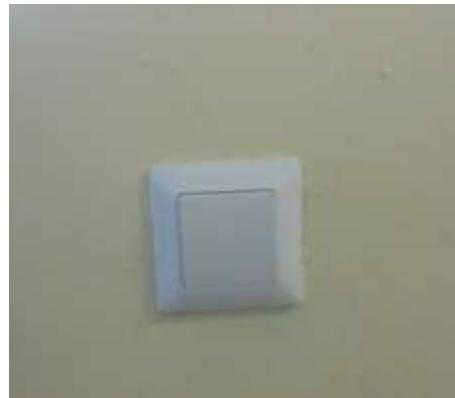
Figure 6: New manual switch
