The European Union's Project IPA 2009, Implementation of Energy Efficiency Measures in Schools and Hospitals in Kosovo

**SUPERVISION OF ENERGY EFFICIENCY MEASURES
IN SCHOOLS AND HOSPITALS IN KOSOVO
Contract No. 2012/302-059**

*Photo Report, on the applied energy
efficiency measures in 6 of 53 schools
(Located in 30 Kosovo municipalities)*

PHOTO REPORT ON A FEW TYPICAL SCHOOLS, BEFORE EEM AND AFTER EEM IMPLEMENTATION OF ENERGY EFFICIENCY MEASURES

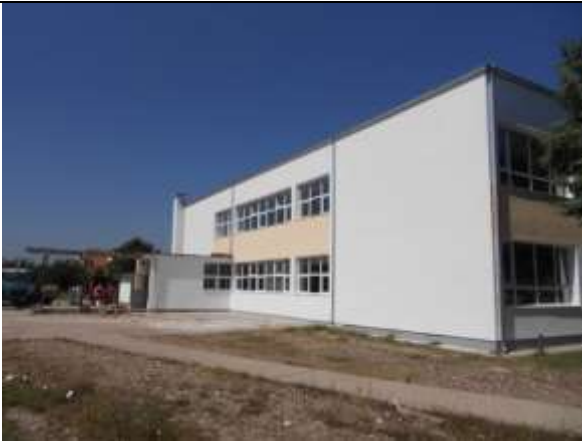
Figure 3: Rear Facade

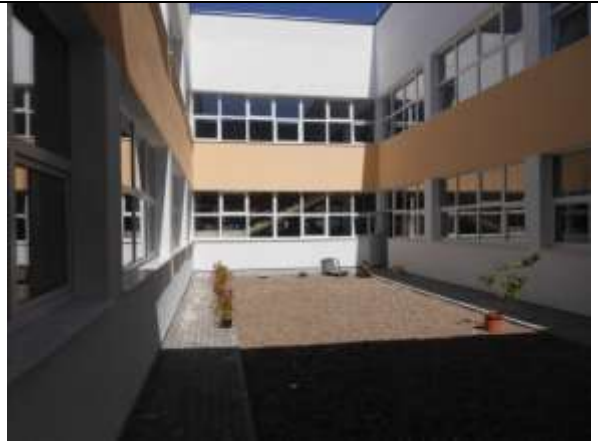
Figure 4: Atrium

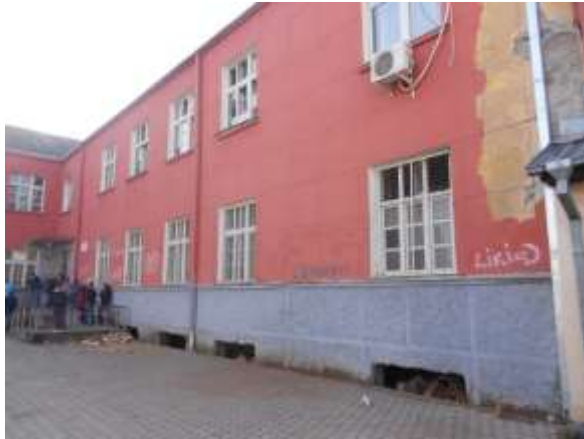
Figure 5: Entrance Facade

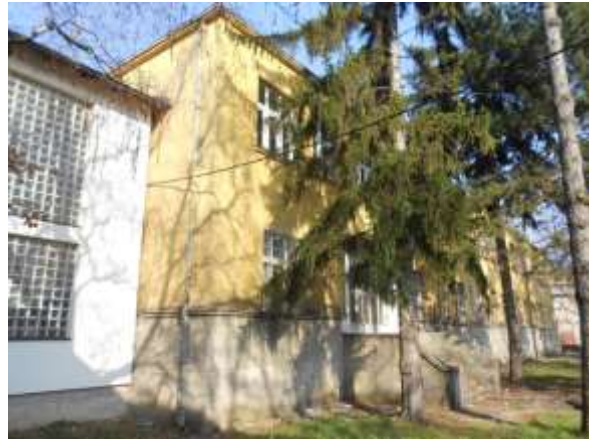
Figure 6:Rear Facade

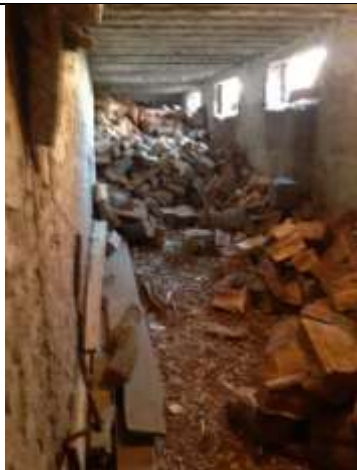
Figure 3: Wood storage

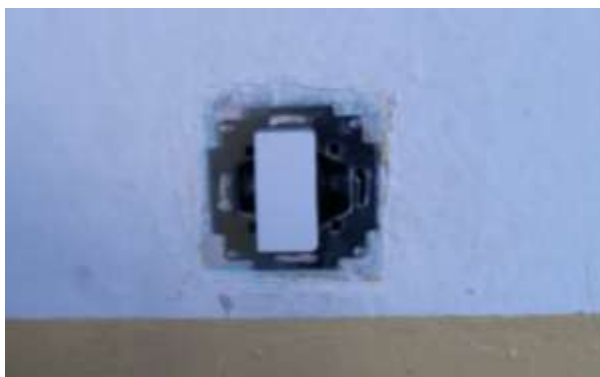
Figure 6: manual switch

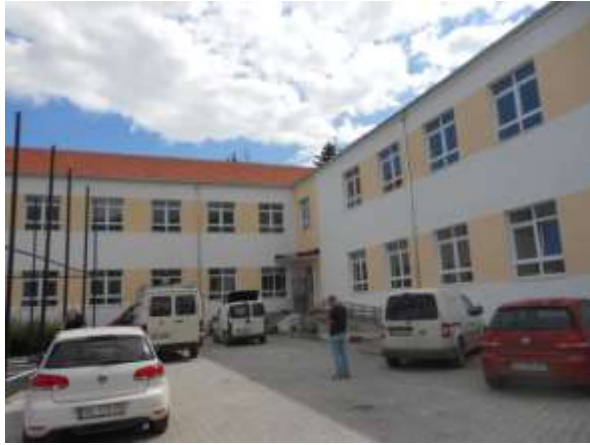
Figure 7: Entrance Facade

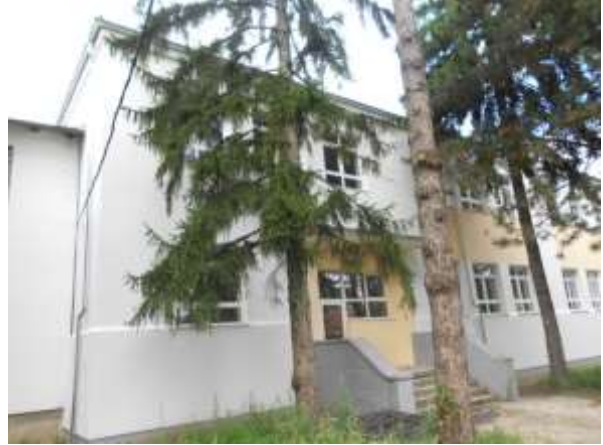
Figure 8: Rear Facade

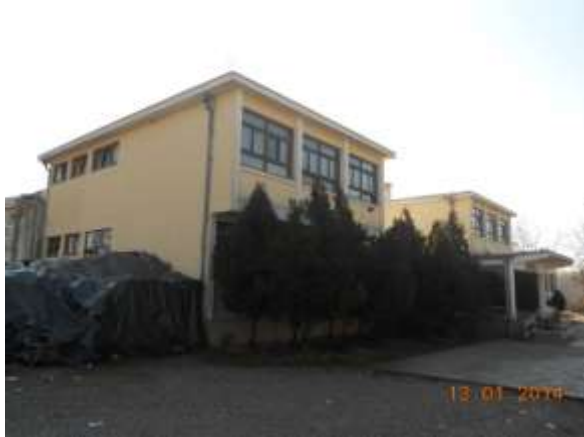
Figure 9: Entrance Facade

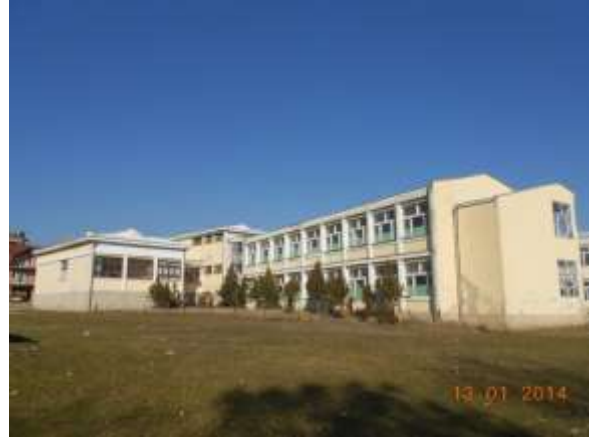
Figure 10:Rear Facade

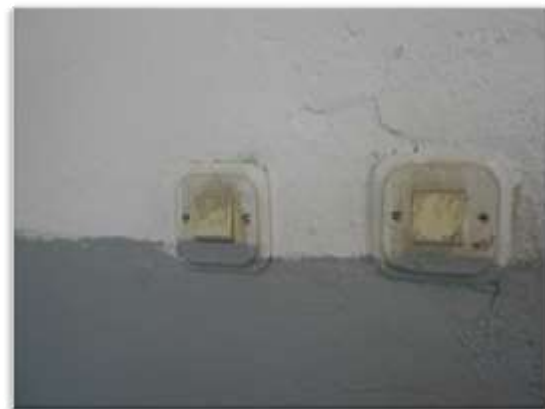
Figure 6: Manual switch

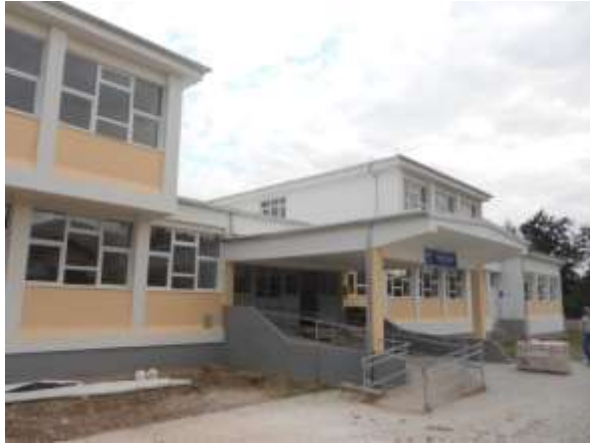
Figure 11: Entrance Facade

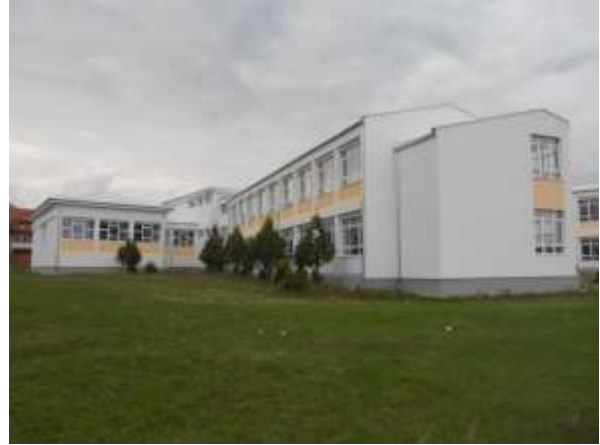
Figure 12: Rear Facade

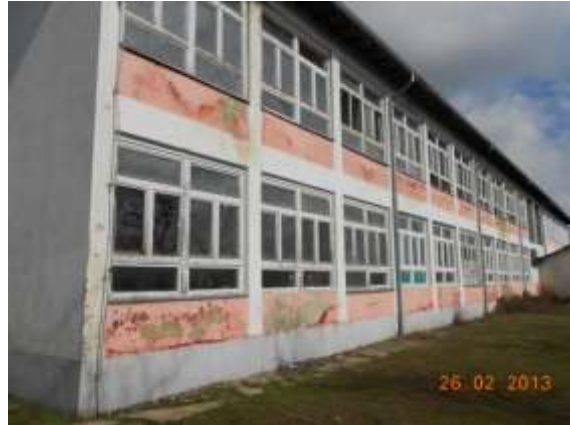
Figure 14:Rear Facade

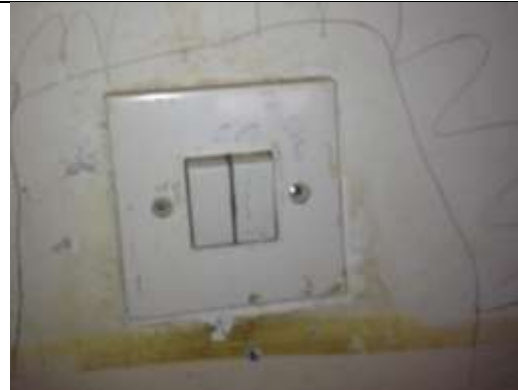
Figure 6: Manual switch

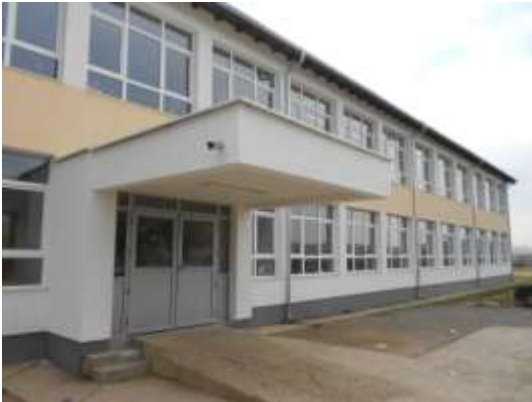
Figure 15: Front Facade

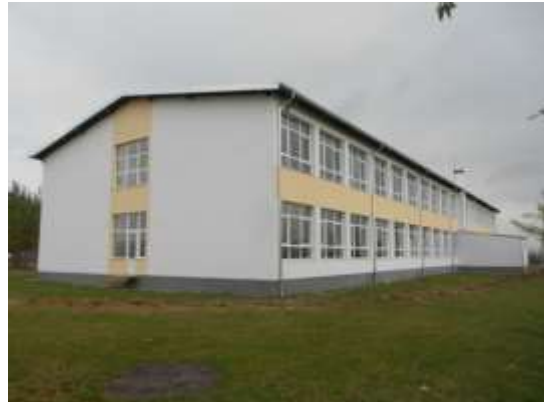
Figure 16: Rear Facade

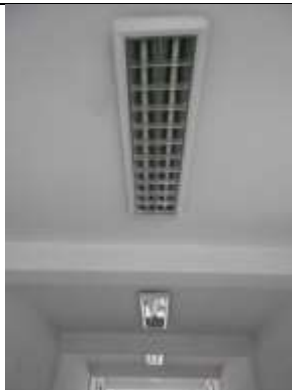
Figure 5: New surface mounted luminaries

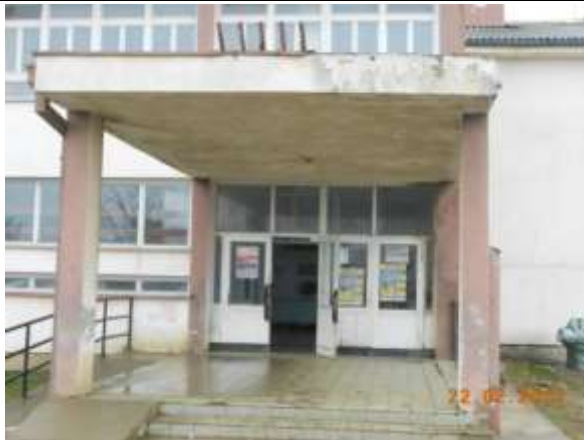
Figure 17: Entrance Portal

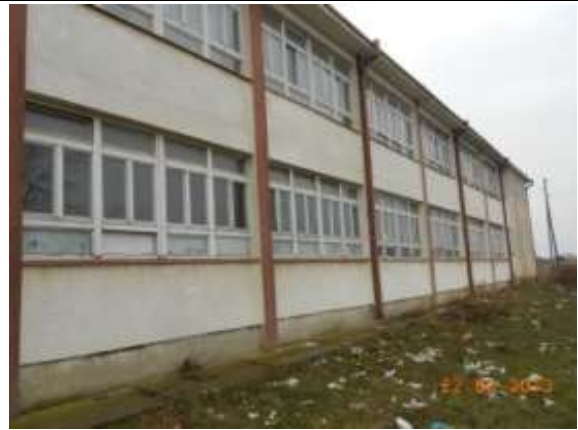
Figure 18:Rear Facade

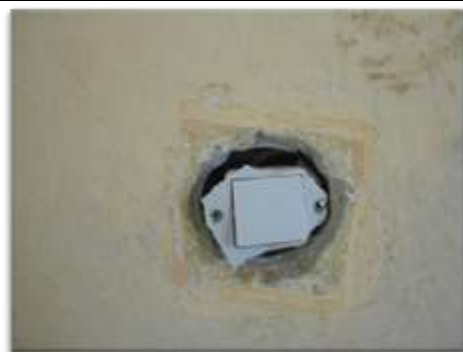
Figure 6: Manual switch

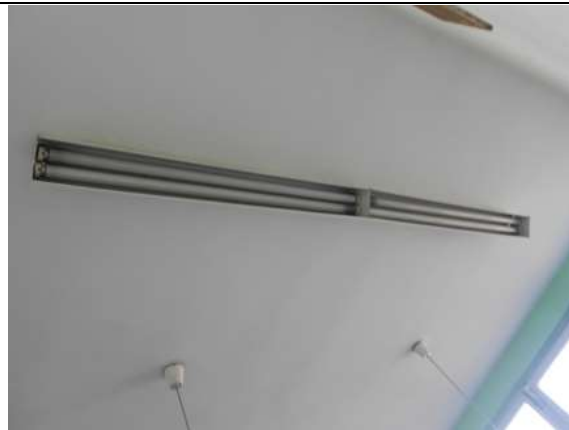
Figure 6: Existing Luminaries

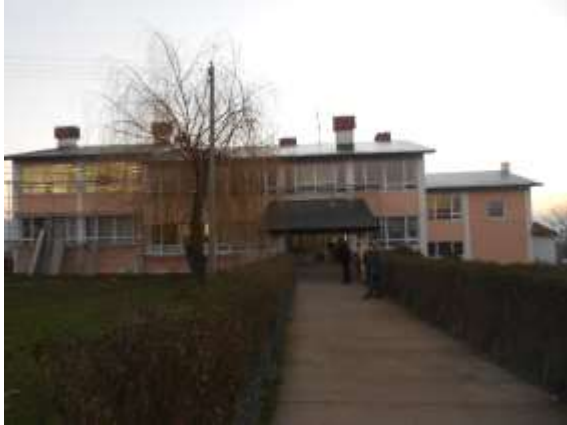
Figure 21: Front Facade

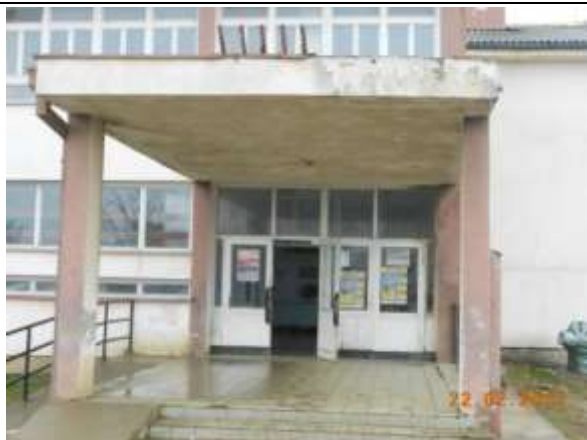
Figure 23: Entrance Portal

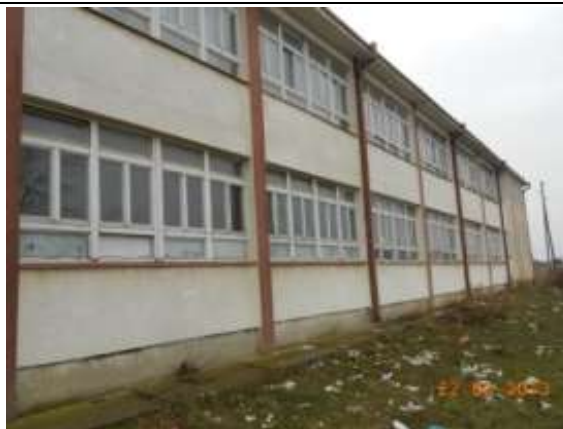
Figure 24:Rear Facade

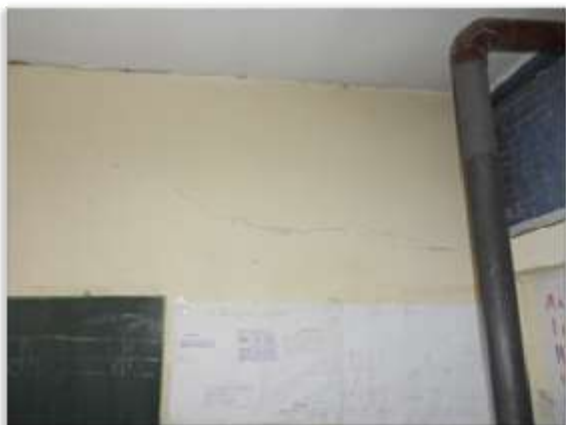
Figure 3: Existing Stoves

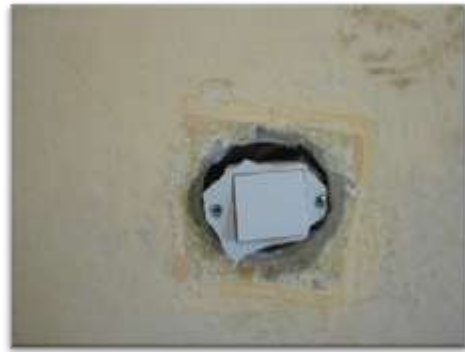
Figure 6: Manual switch

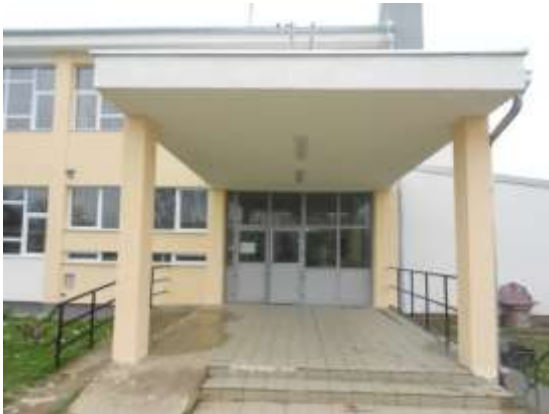
Figure 25: Entrance Portal

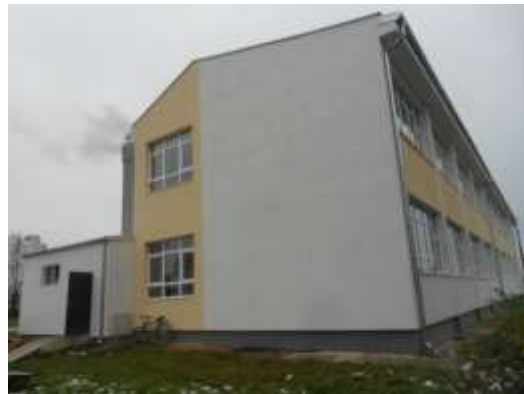
Figure 26: Rear Facade
